BUREAU OF SHIPS
TECHNICAL INSPECTION REPORT.

OPERATION CROSSROADS.
U.S.S. FALLON (APA 81).

TEST BAKER.

VOLUME 2 [U].

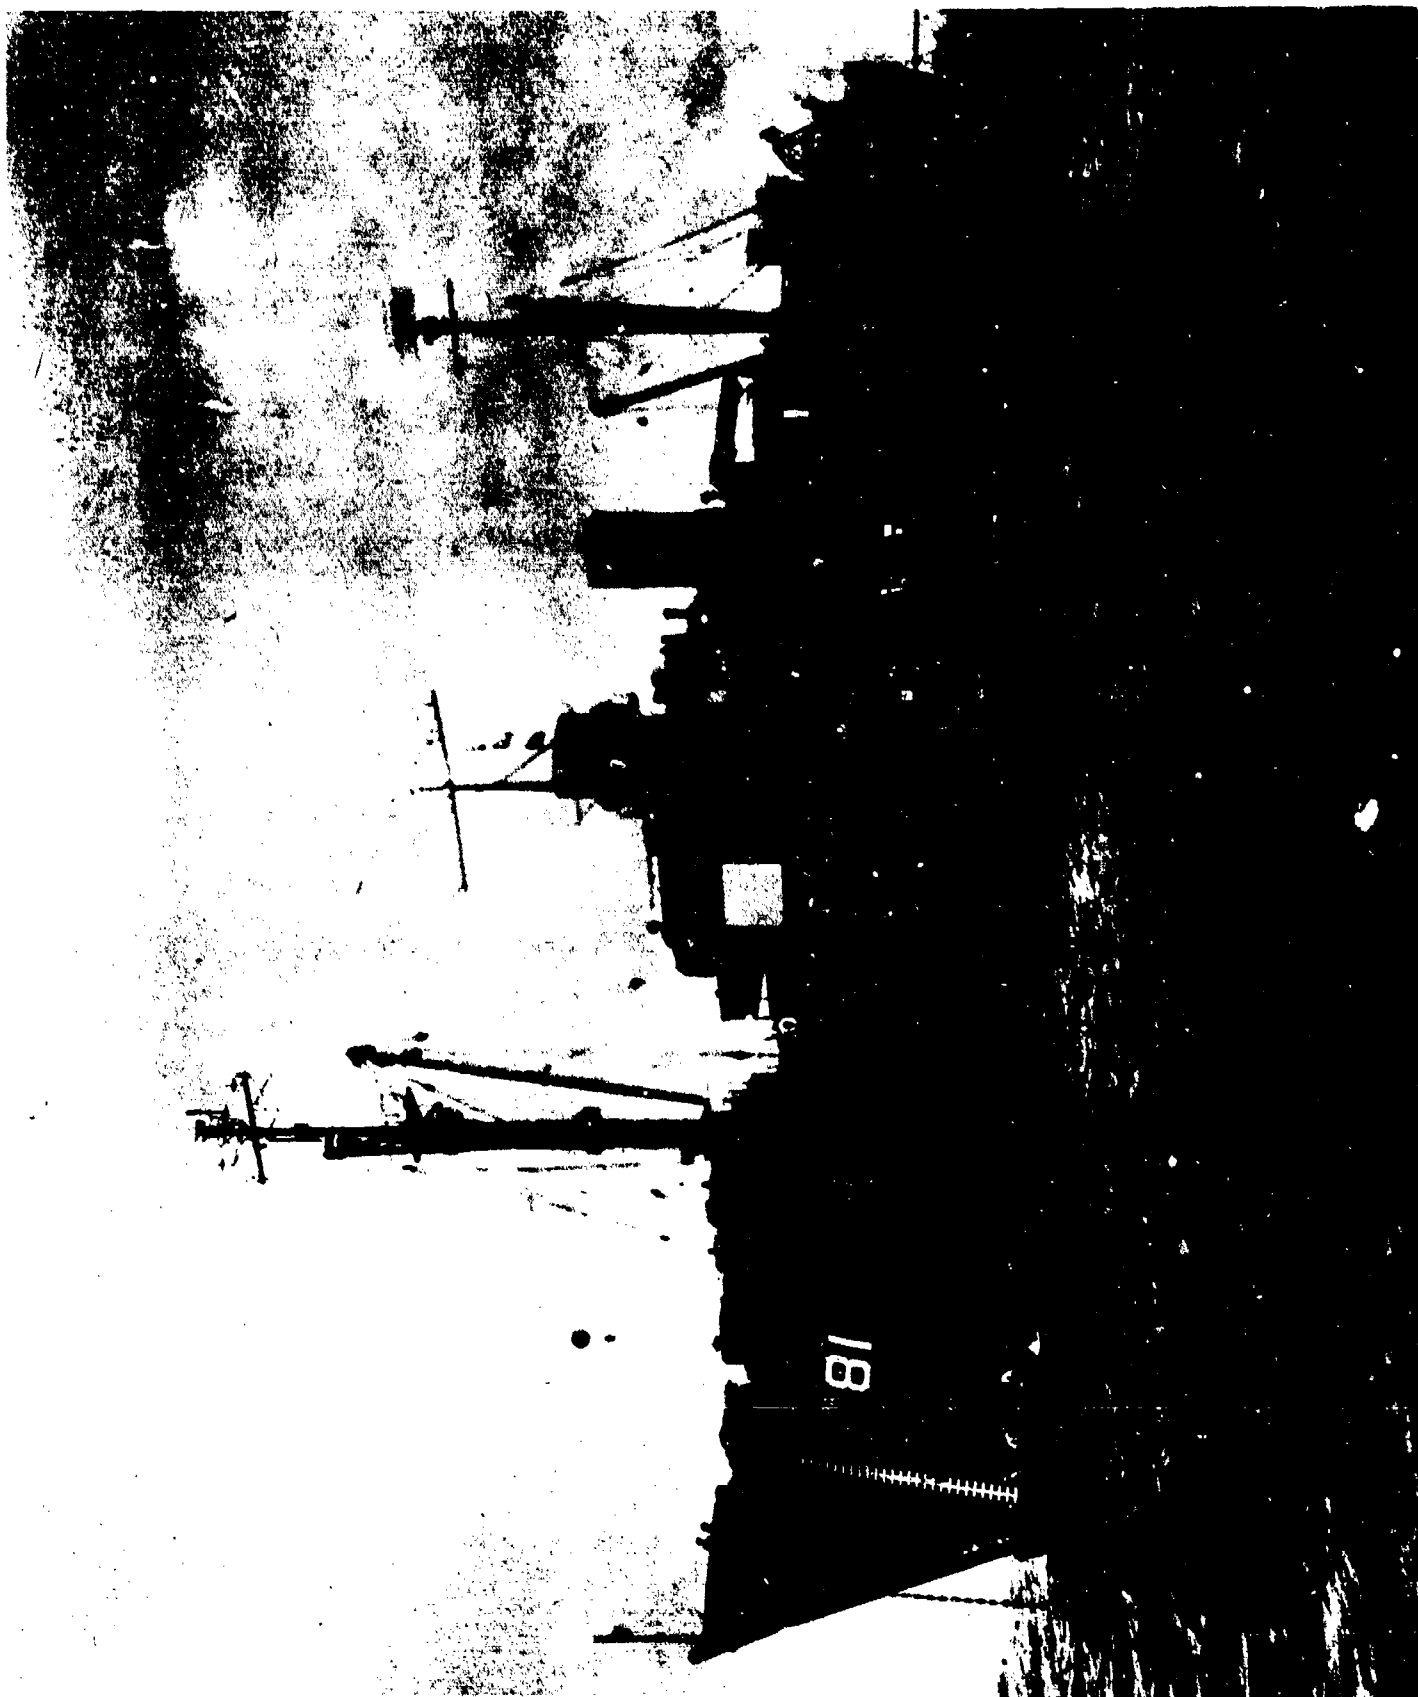
BB-CR-227-513-63. Exterior view on port bow before Test B.

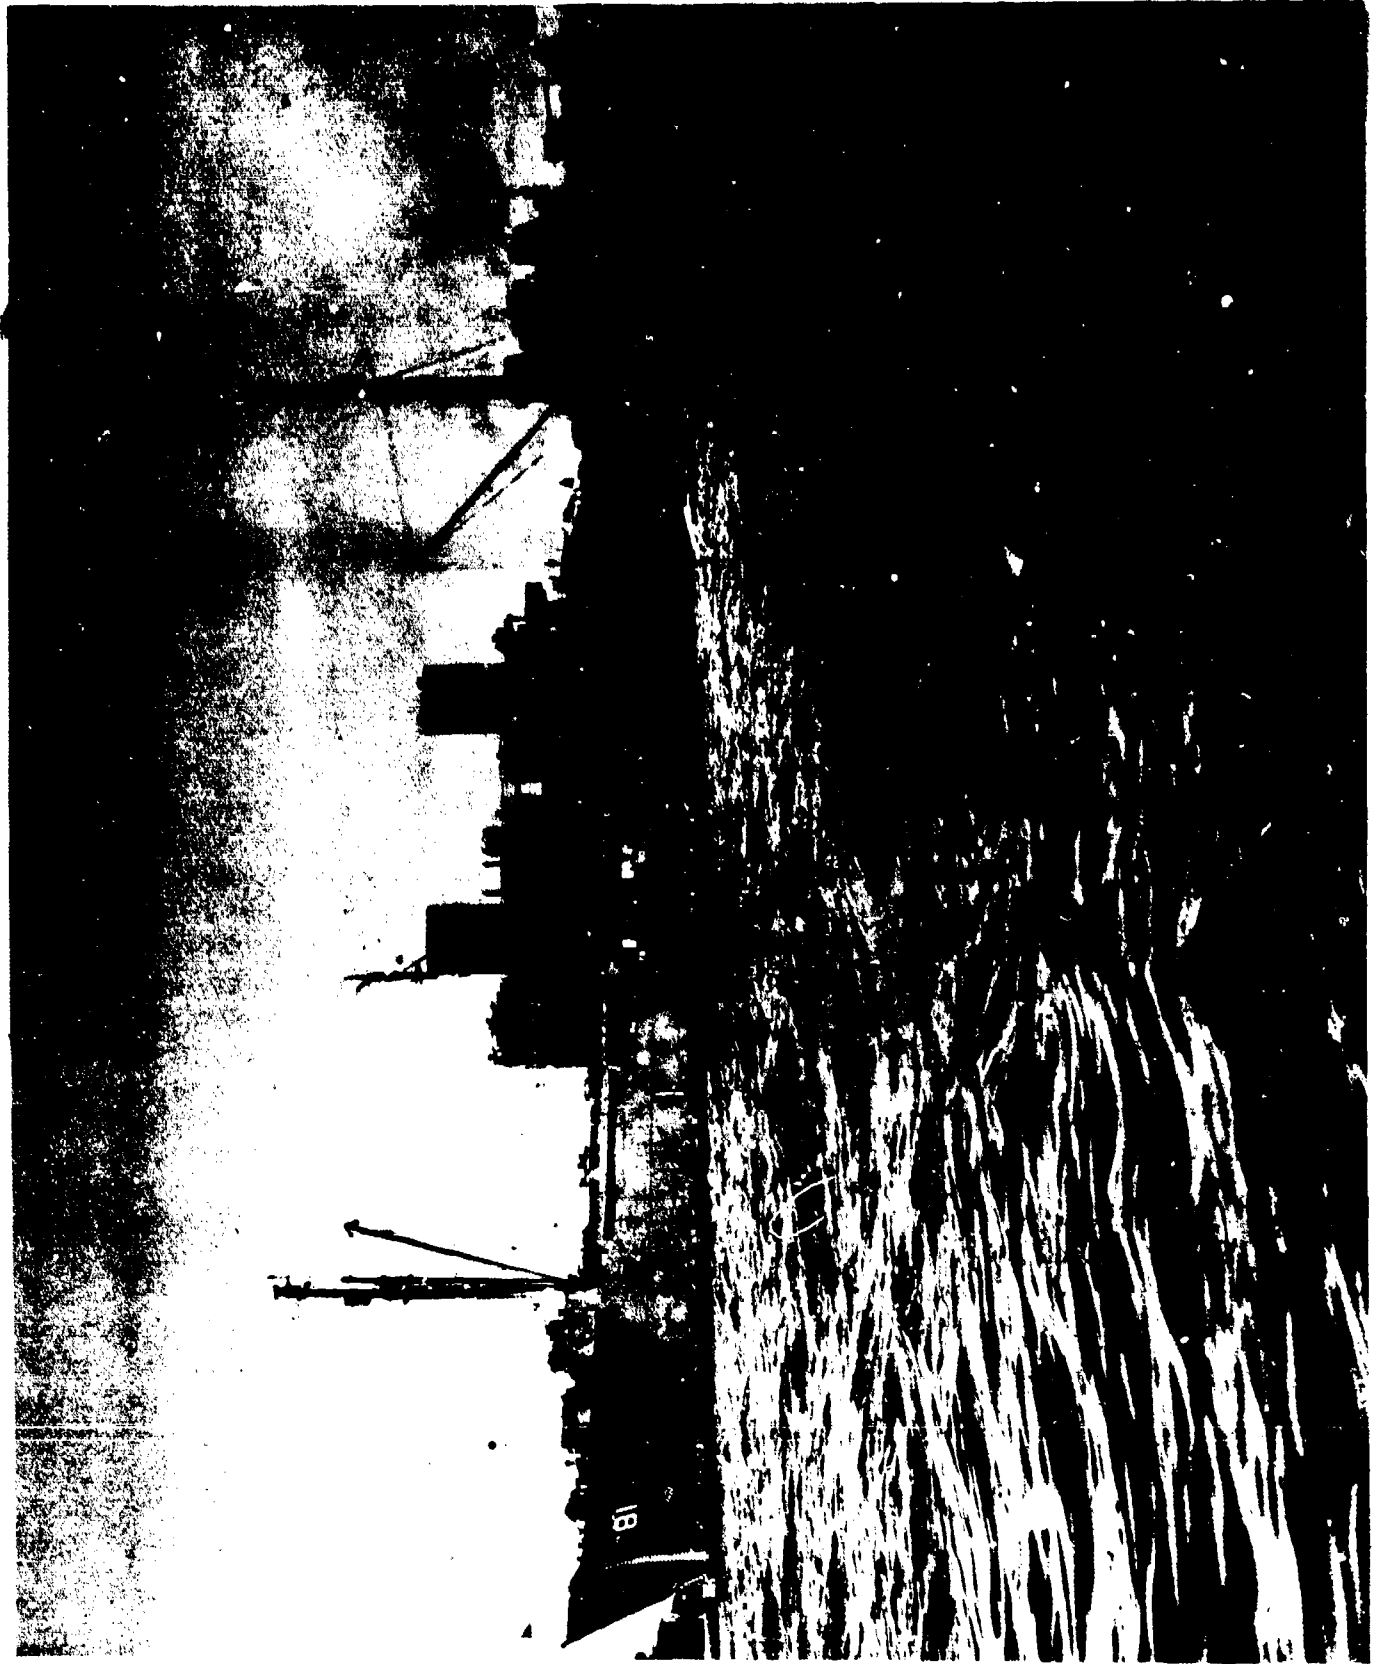
BB-CR-227-513-64. Exterior view on port beam before Test B.

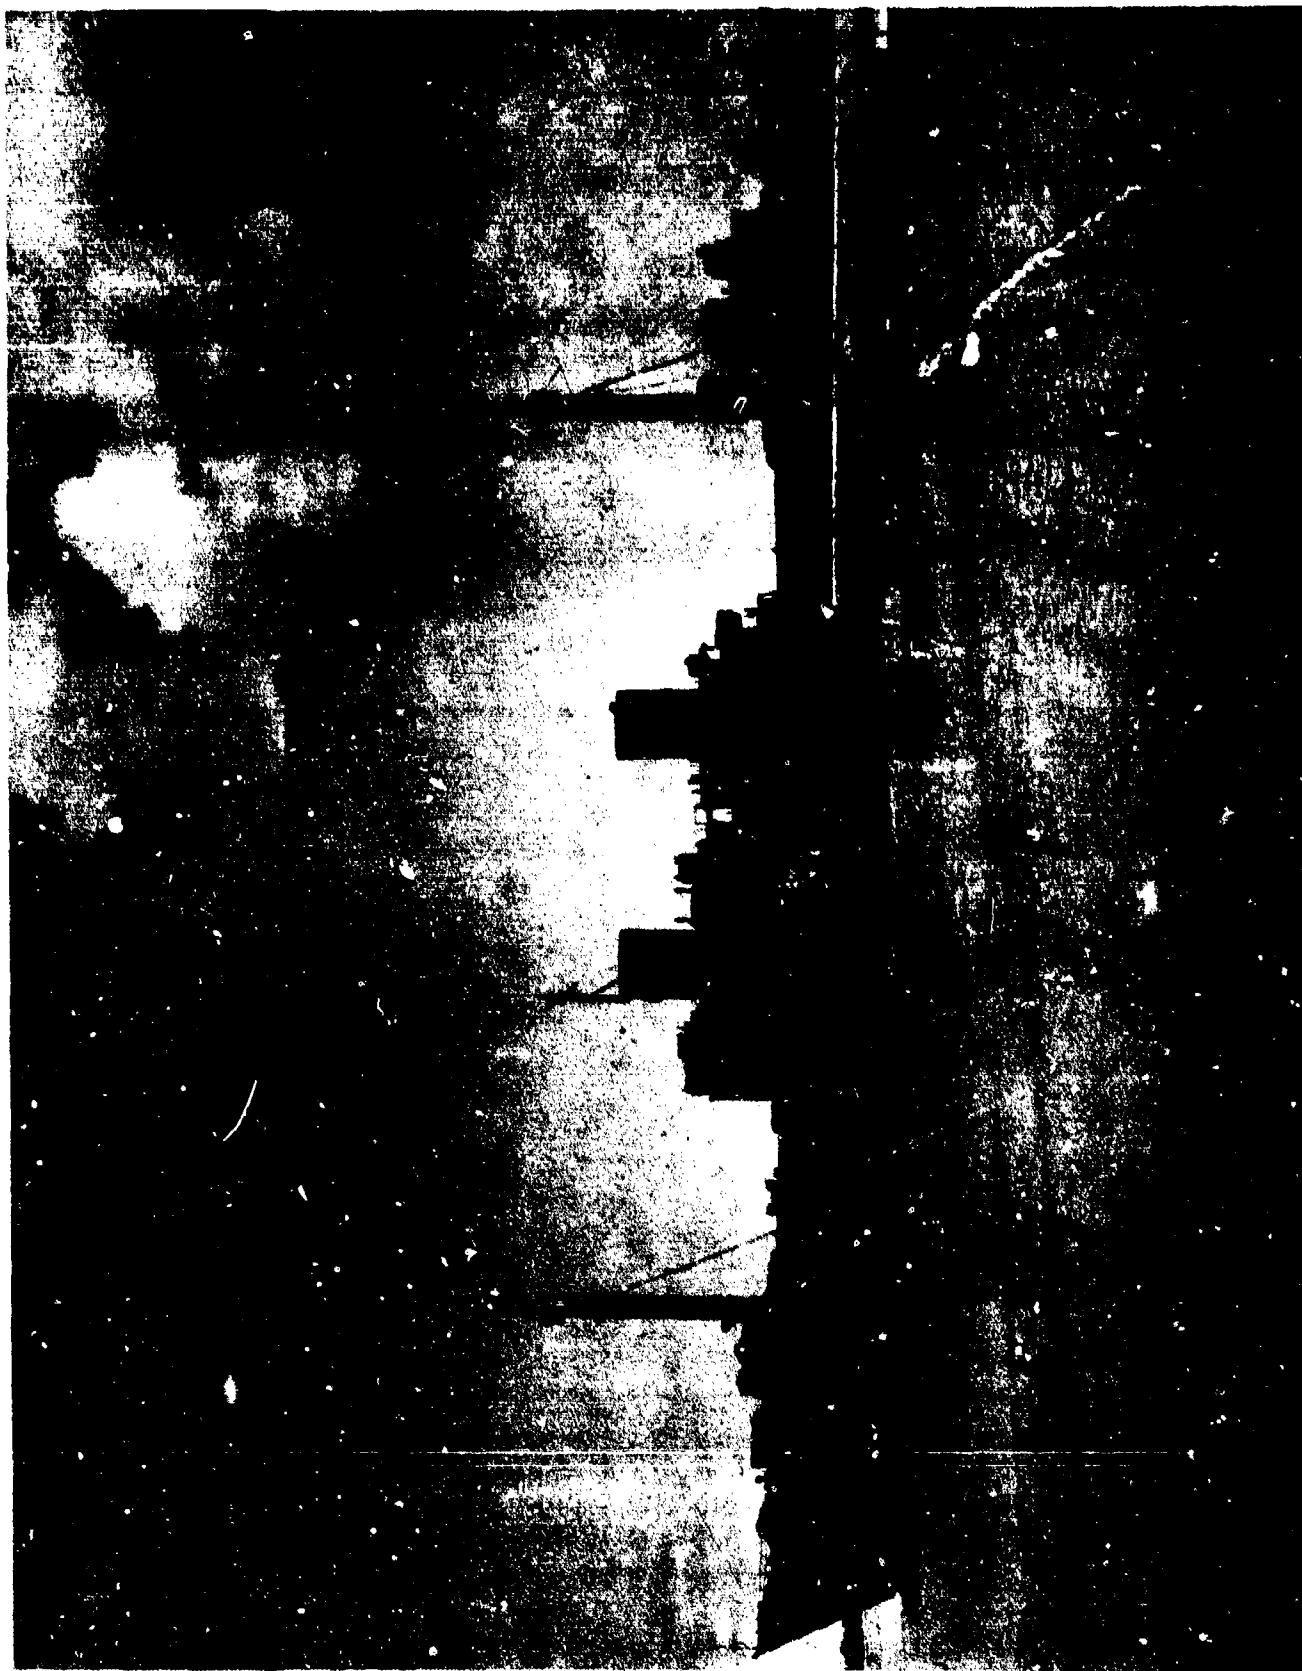
AB-CR-227-290-13. Exterior view on port beam after Test B.

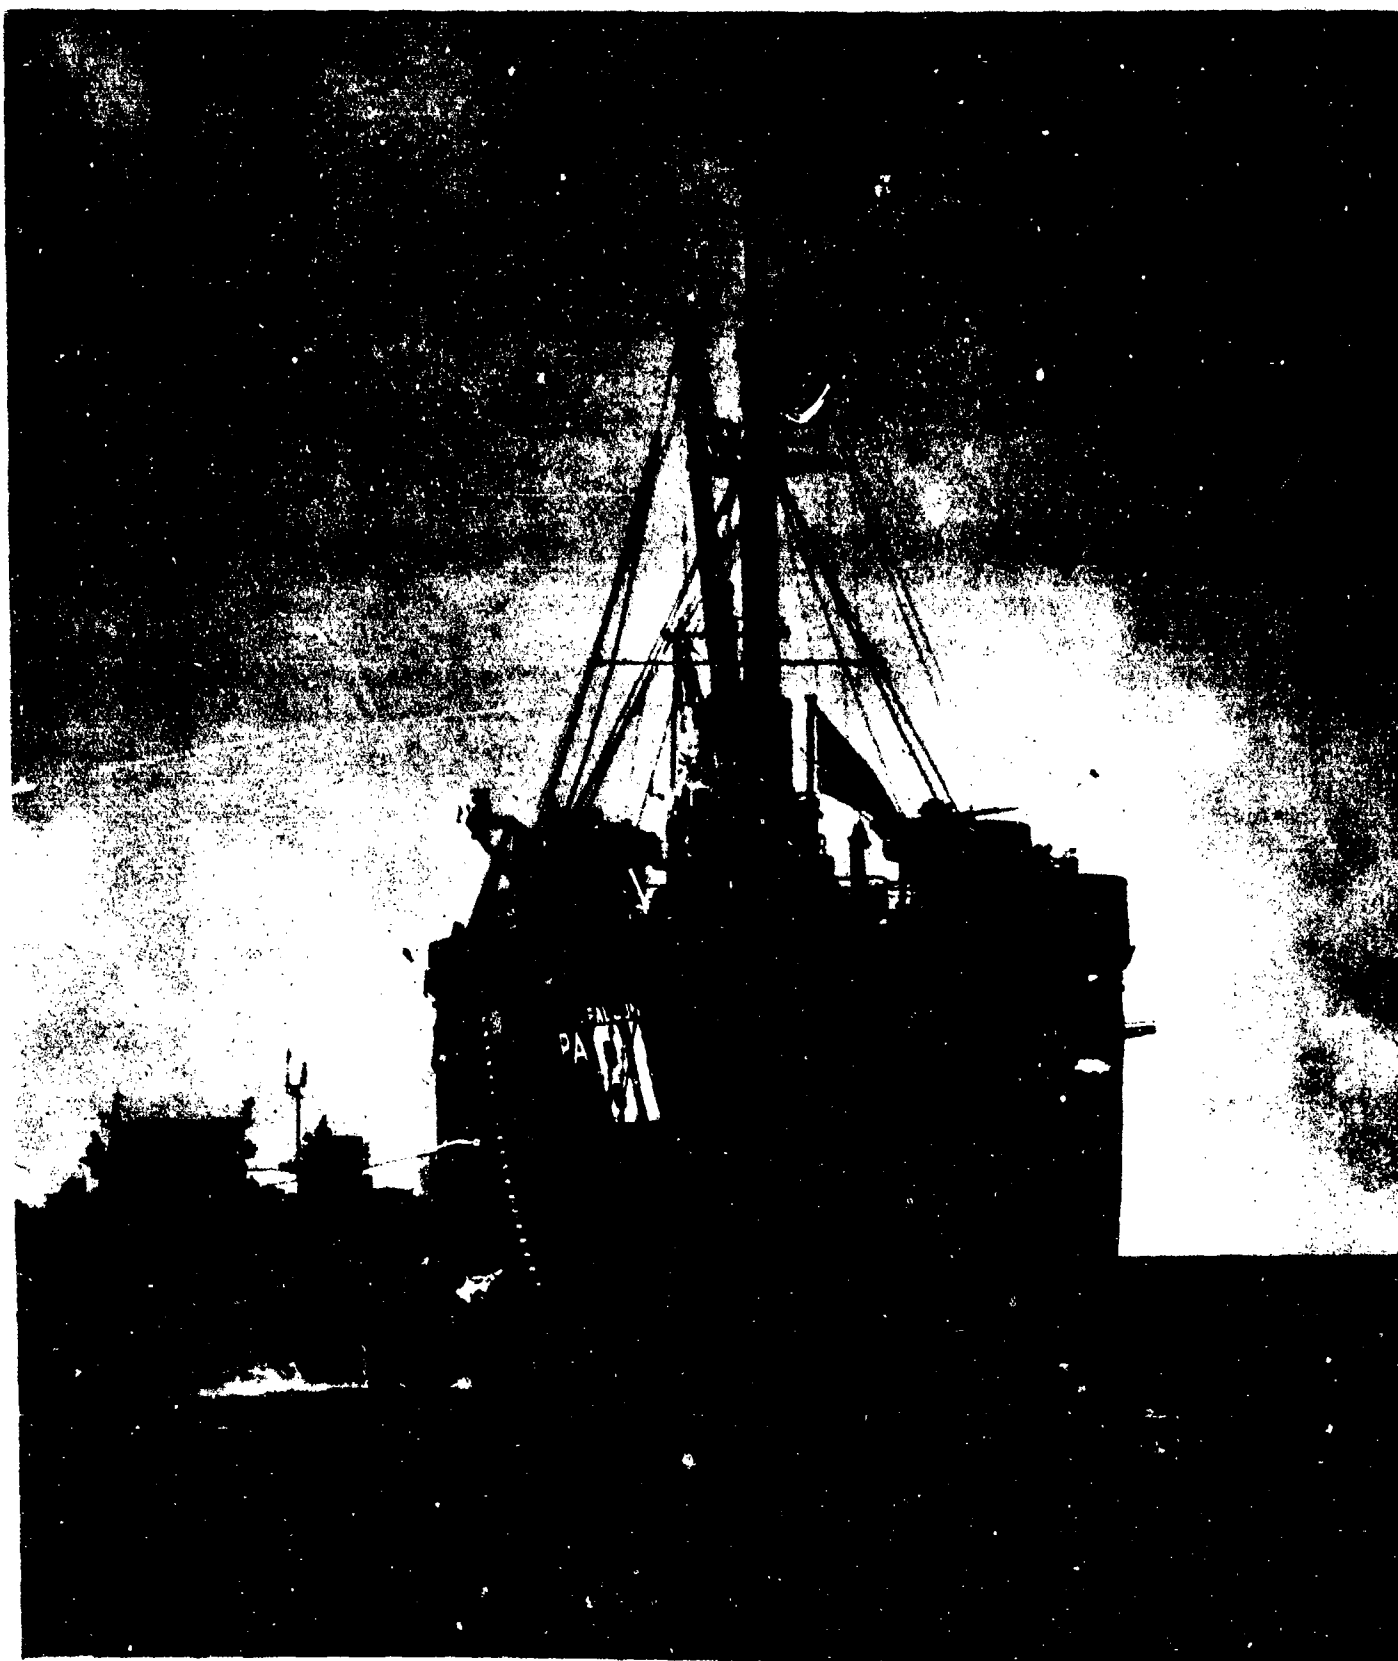
BB-CR-227-513-66. Exterior view from stern before Test B.

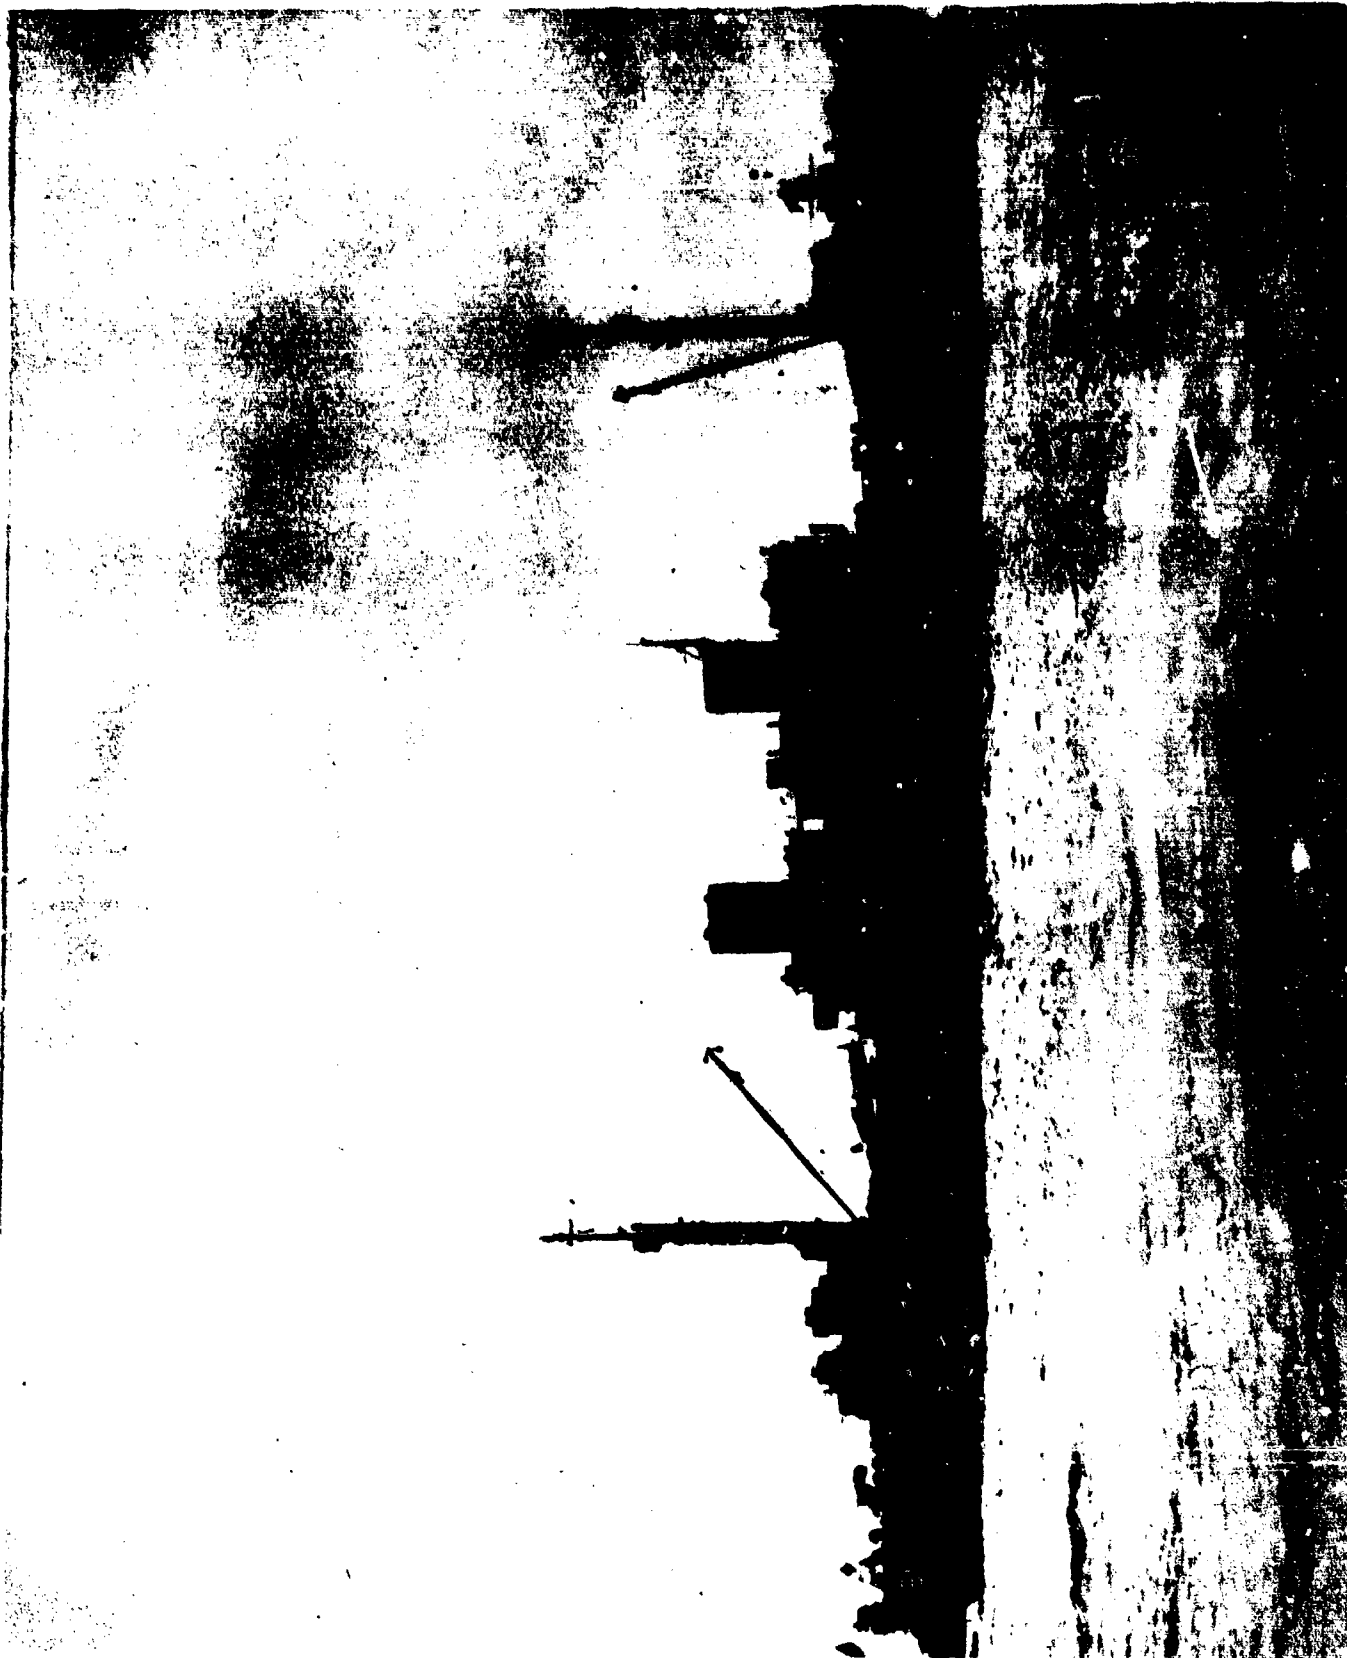
BB-CR-227-513-68. Exterior view on starboard beam before Test B.

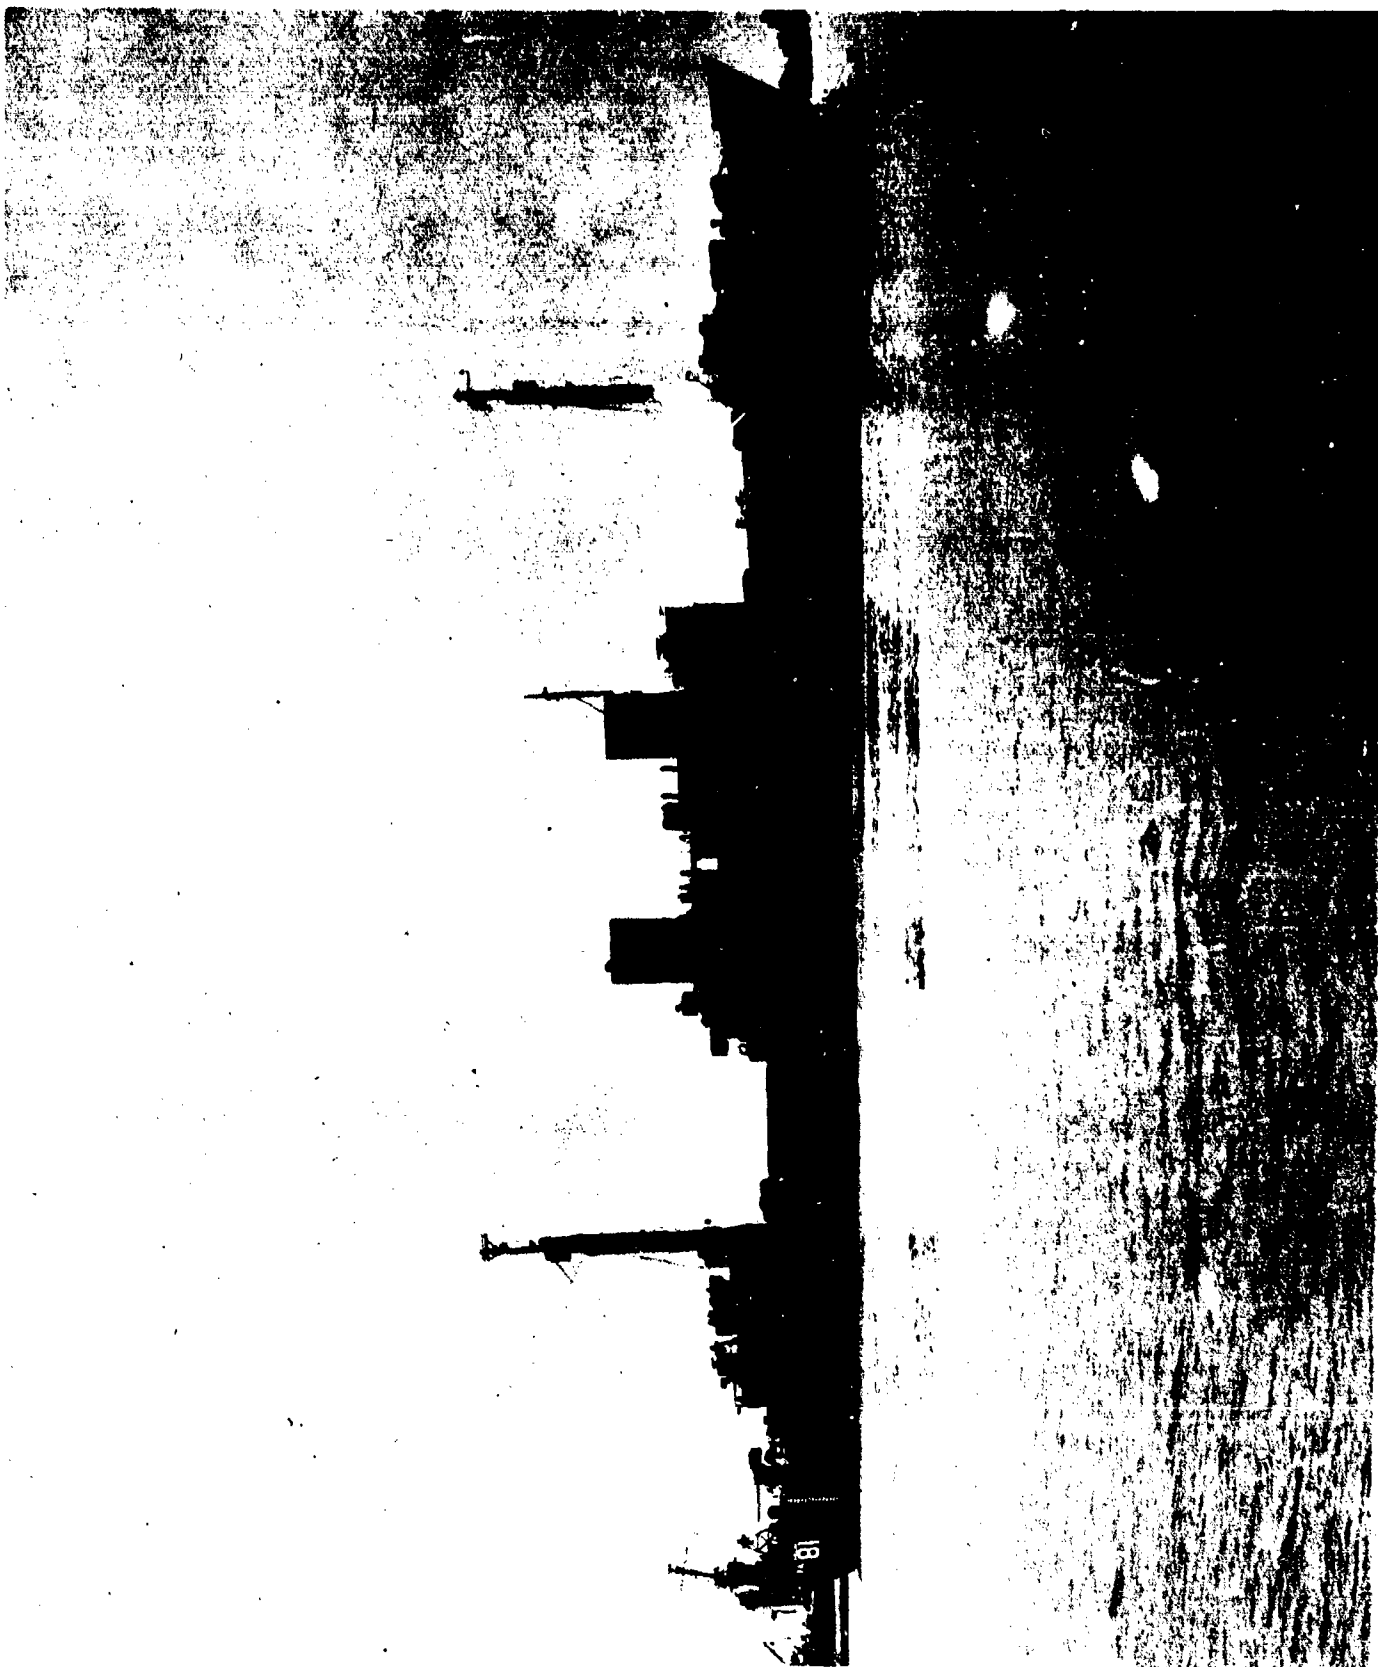
AB-CR-227-290-9. Exterior view on starboard beam after Test B.

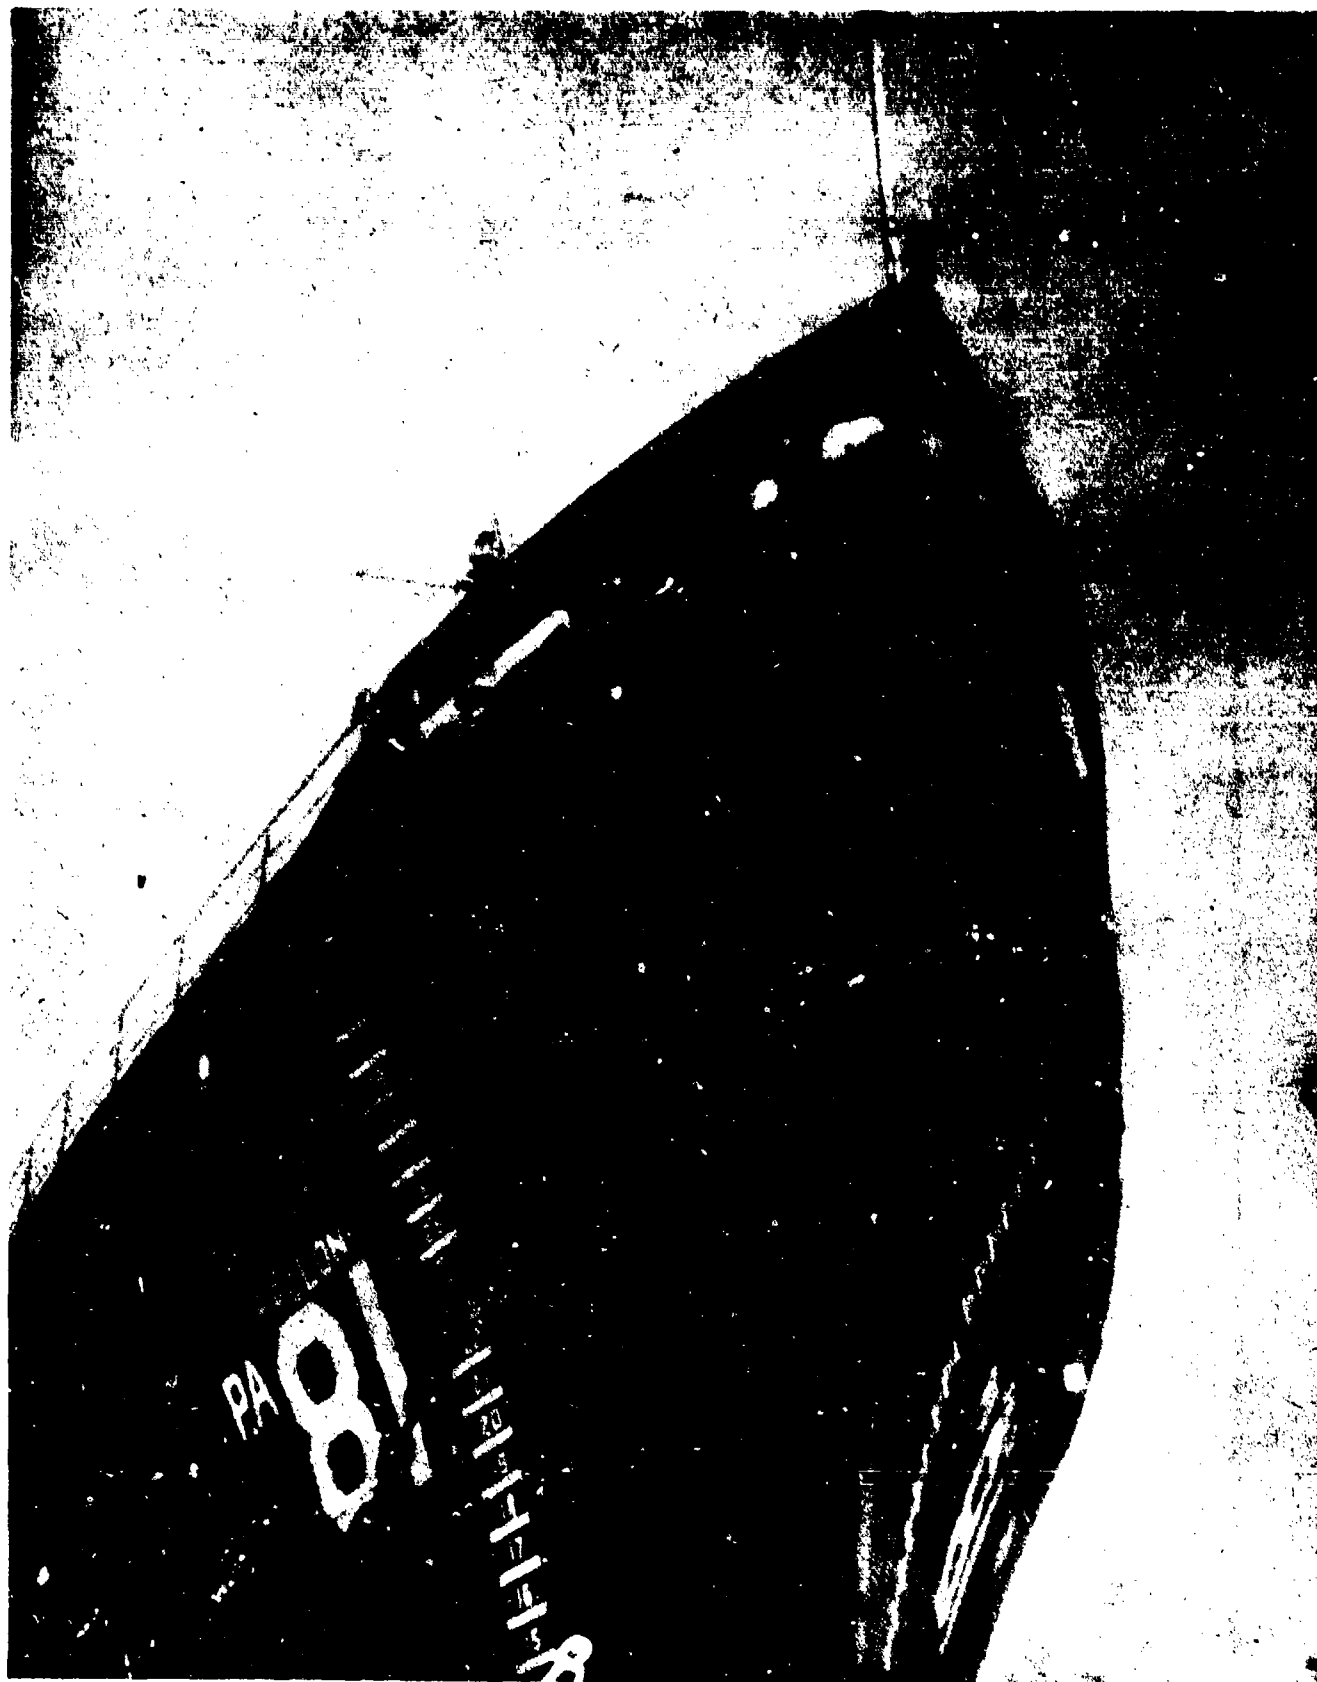
AB-CR-80-2988-8. Damage to stem between main and upper decks.
Note damage to port sheer strake about frame 10.

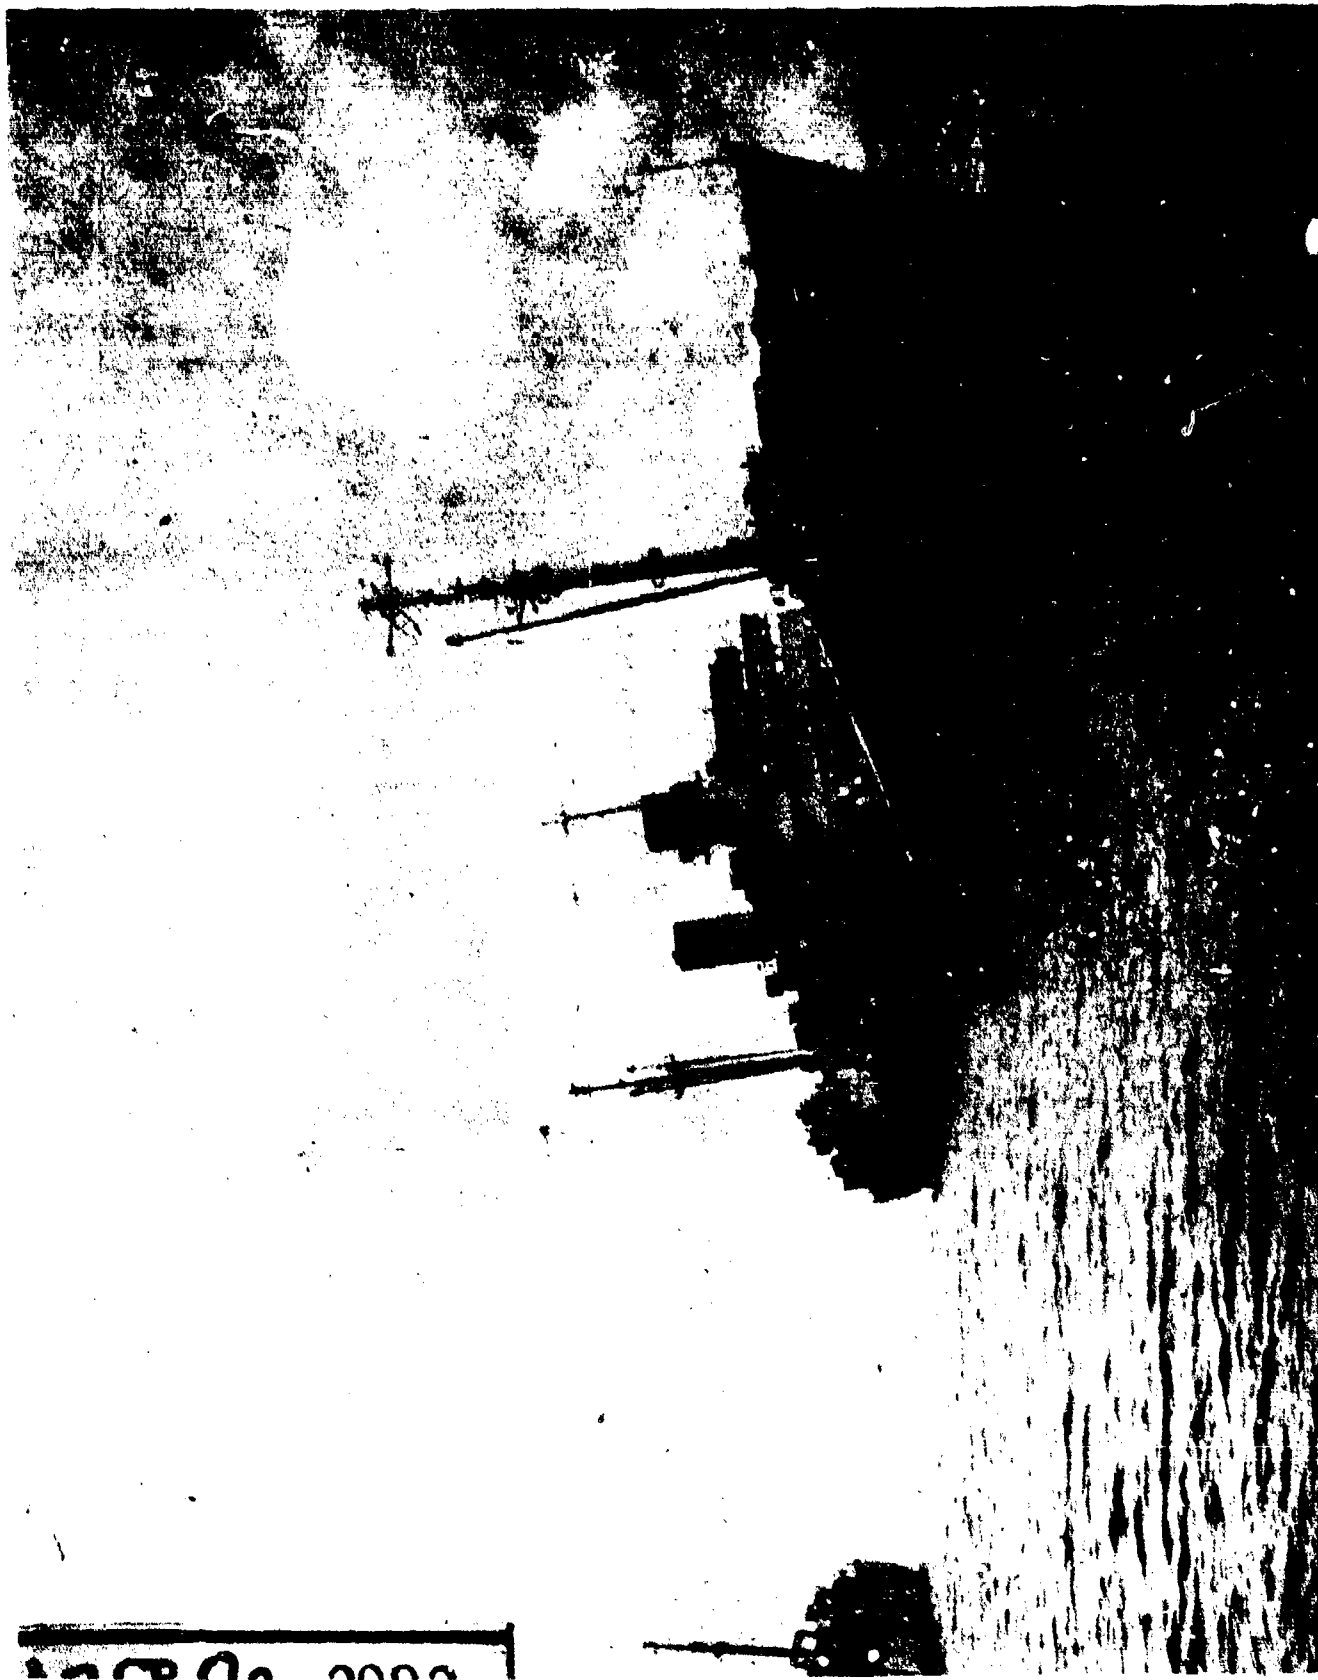
AB-CR-80-2092-5. Exterior view prior to beaching, looking from broad on the starboard bow.

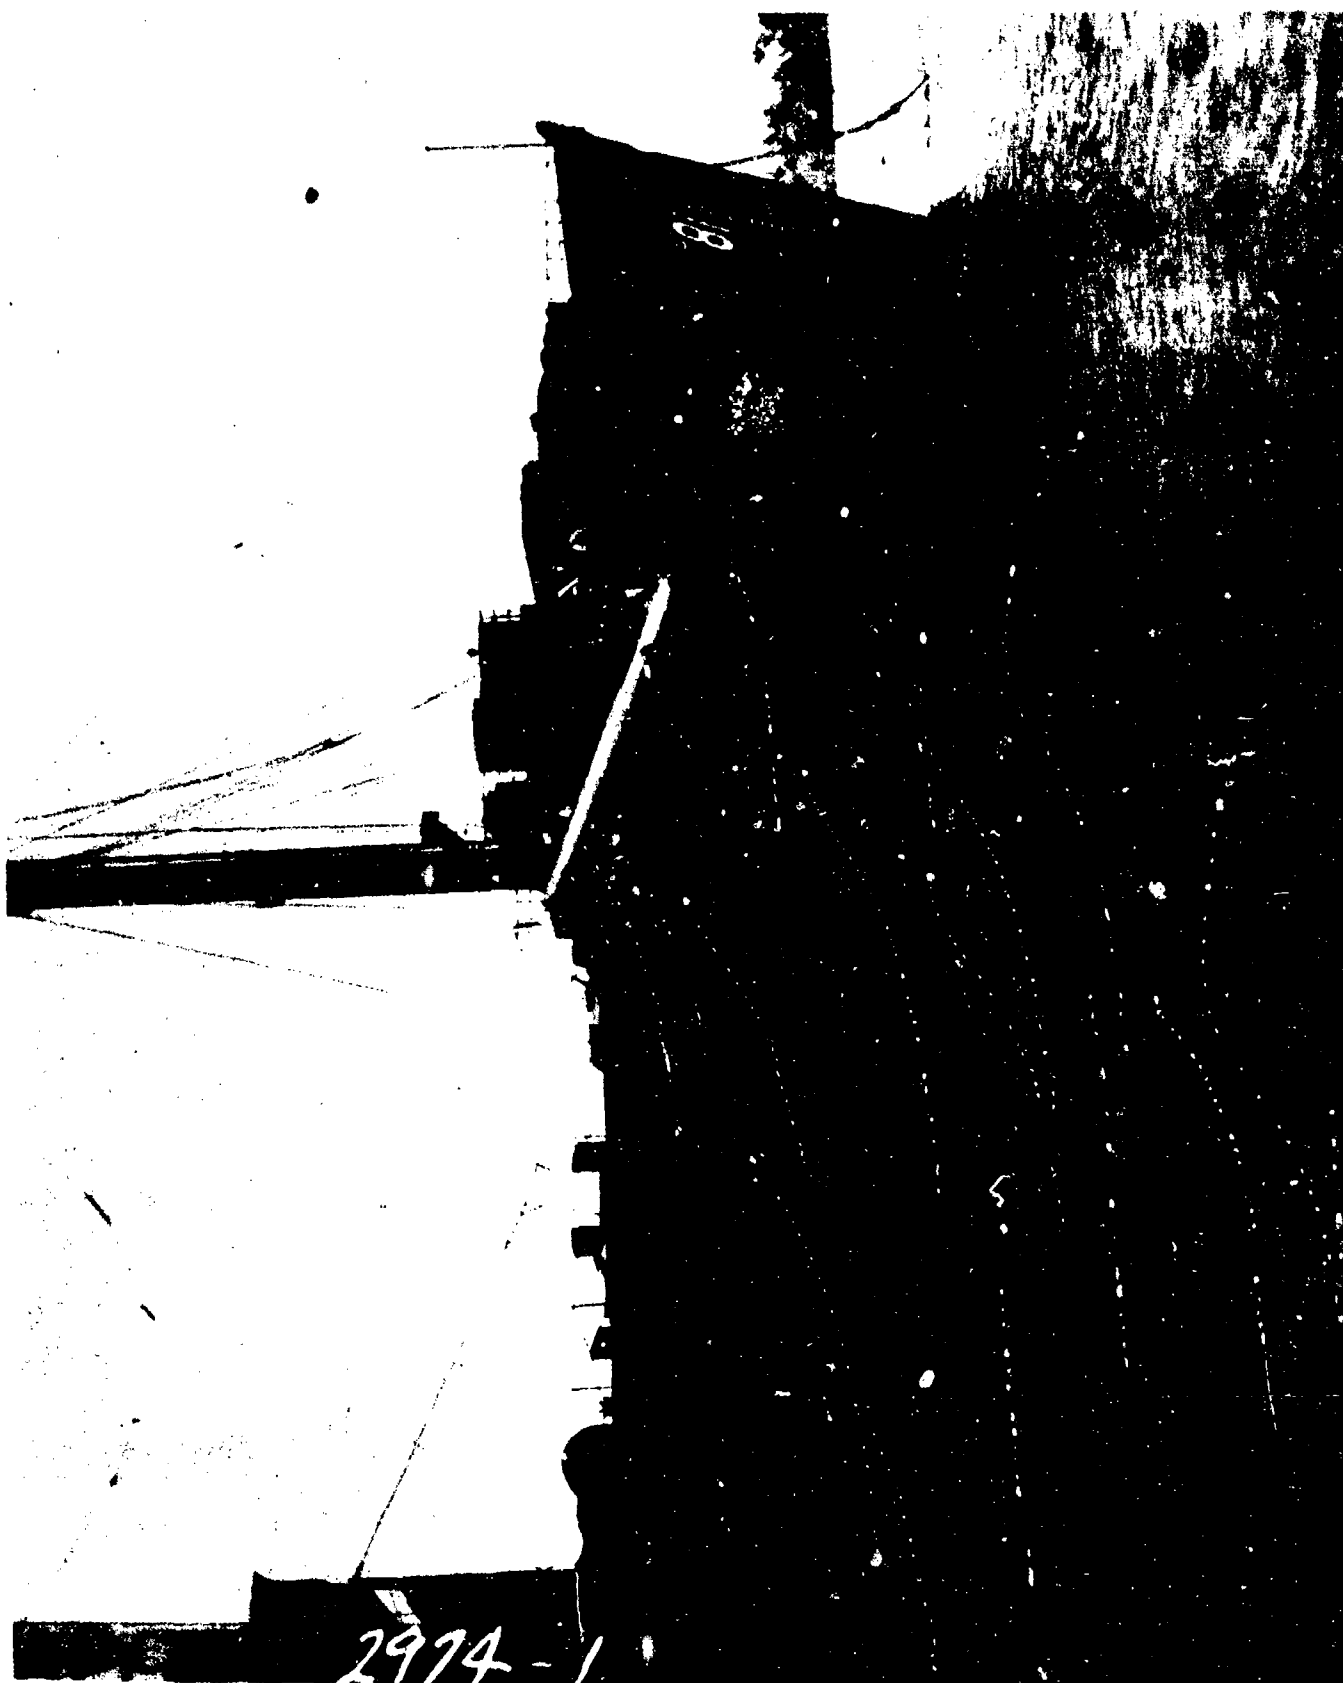
AB-CR-79-2974-1. Starboard side, bow to frame 62.

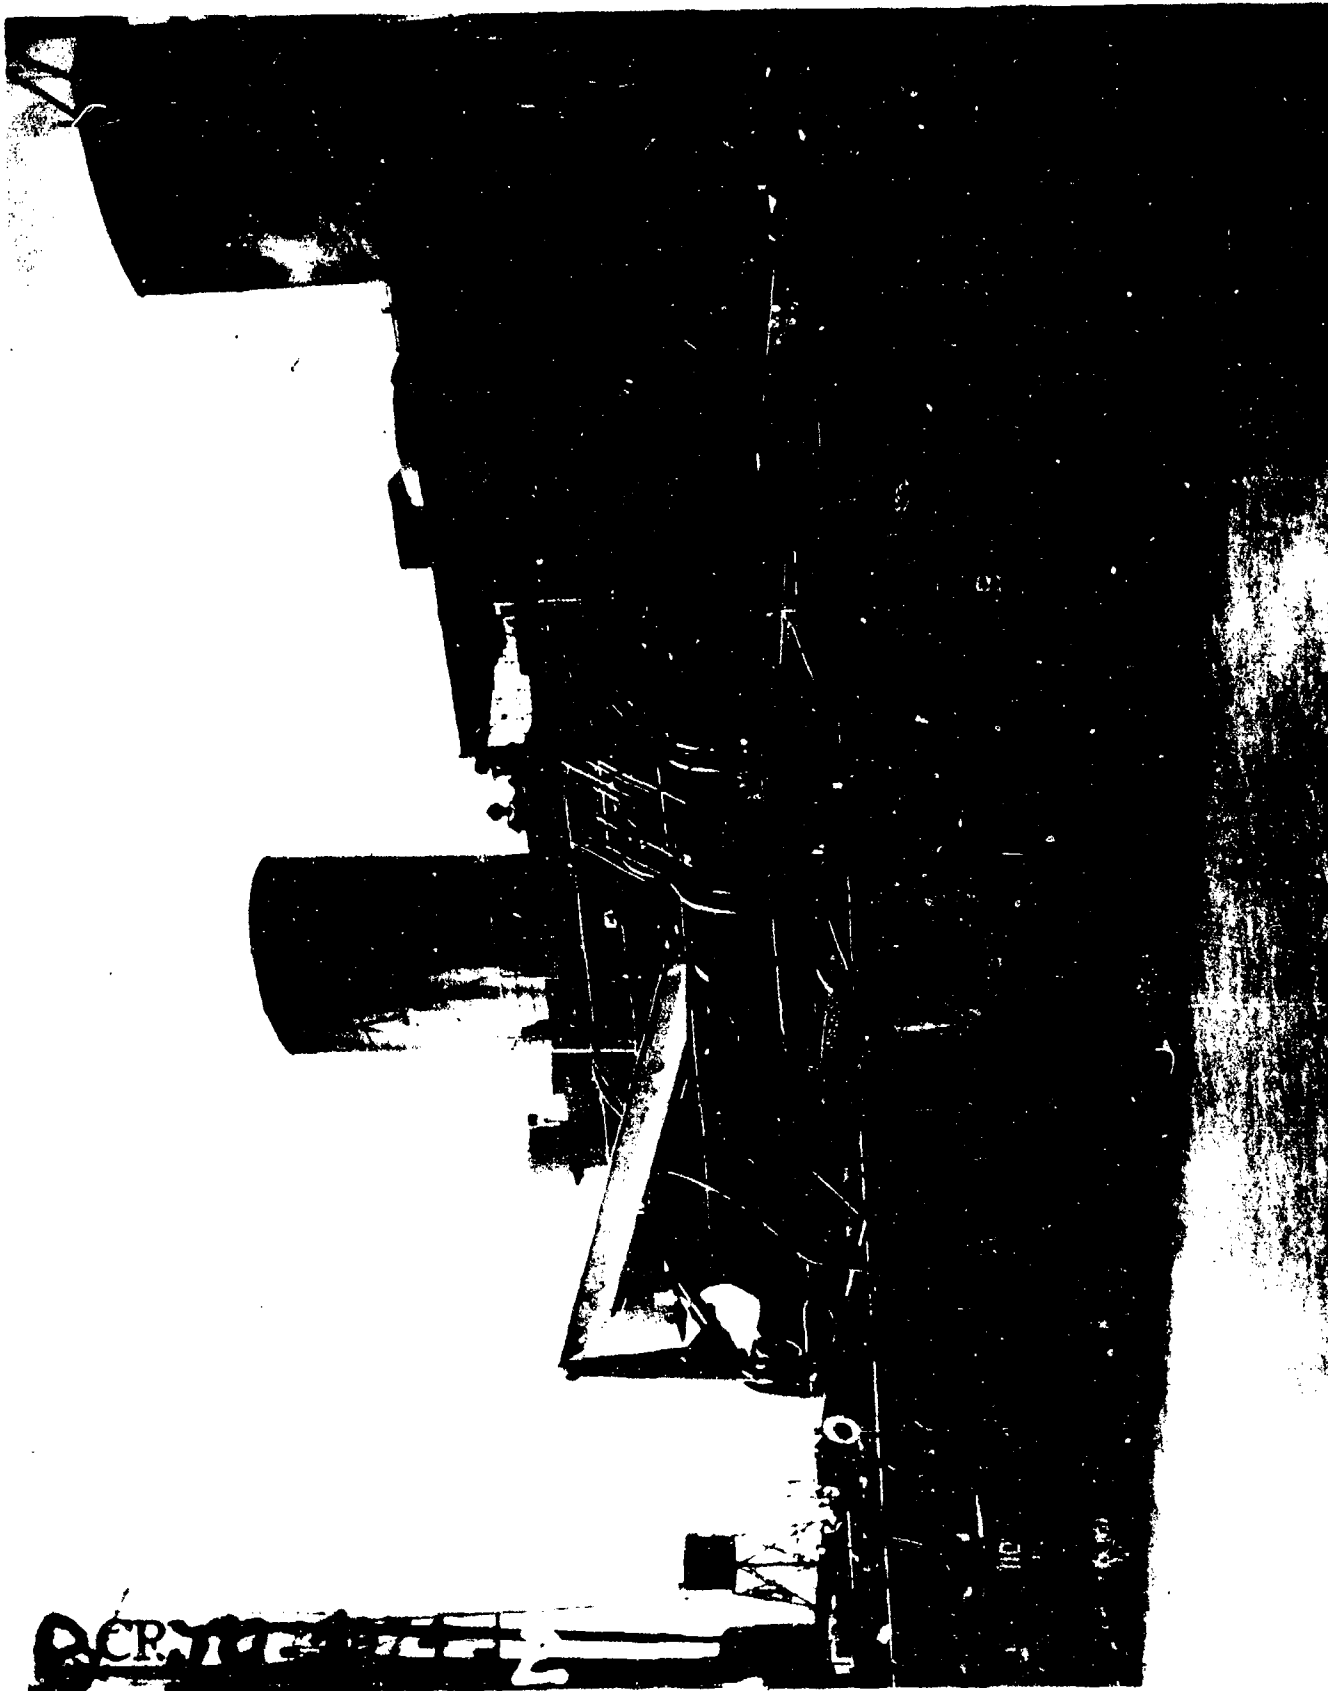
AB-CR-79-2974-2. Starboard side, amidships.
